Test Report

No. 509 19675e*

Component test of the SPAX frame anchor

Fastening system - SPAX frame anchor

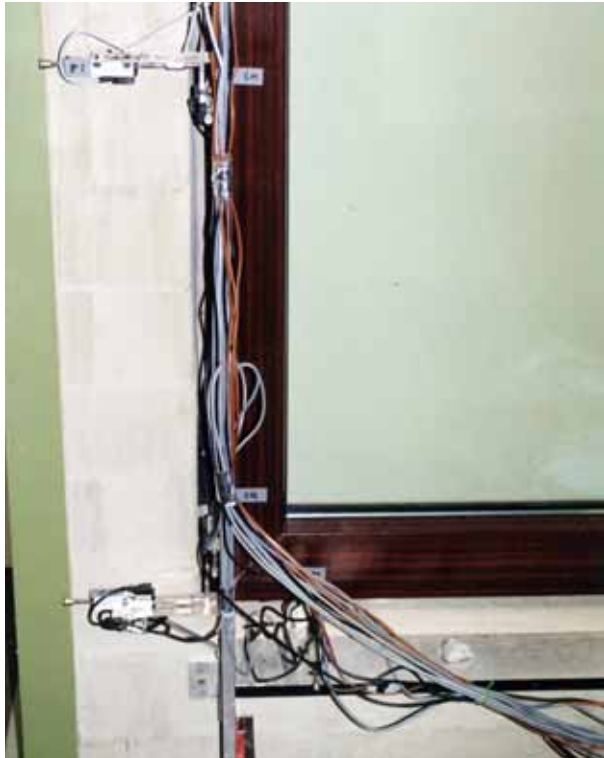
Fig. 6 Test setup

1. Visual inspection of the position and arrangement of the fasteners in the window and towards the wall,
2. Testing of operating forces,
3. Deformation of the window in the initial condition and under application of a 500 N load to the edge of the casement as per DIN 18055. The displacement of the window in the mounting area was recorded by a total of 20 linear potentiometers. Fig. 5 shows the positions of the linear potentiometers. Fig. 6 shows part of the test setup.

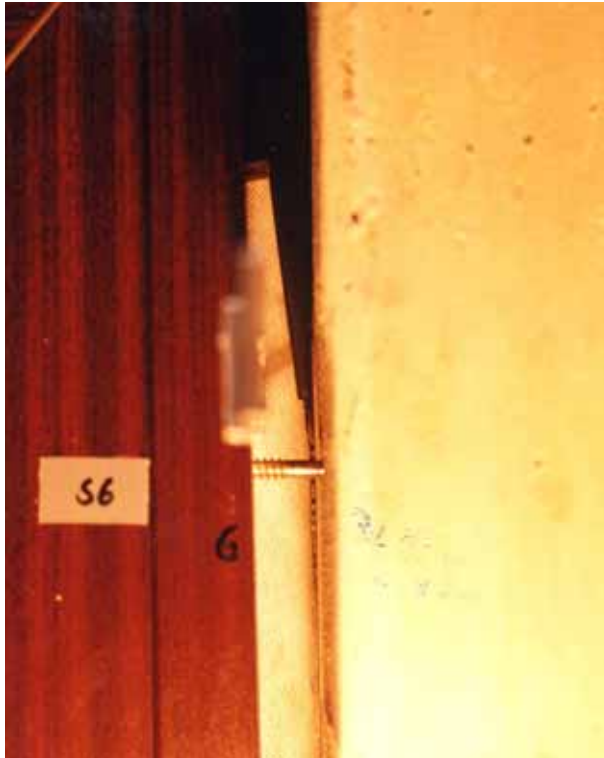
Fig. 8 shows the blocking and the SPAX frame anchor in the top right corner (seen from inside).

Fig. 8 Fixing and blocking at the top corner

The frame anchor RA 7.5 x 180 was retained firmly by at least two walls of the side brick. The top fixing ran into the precast lintel, therefore the RA 7.5 x 120 frame anchors were used. The downward fixing ran into sand-lime brick. The screws held firmly at the top and bottom.

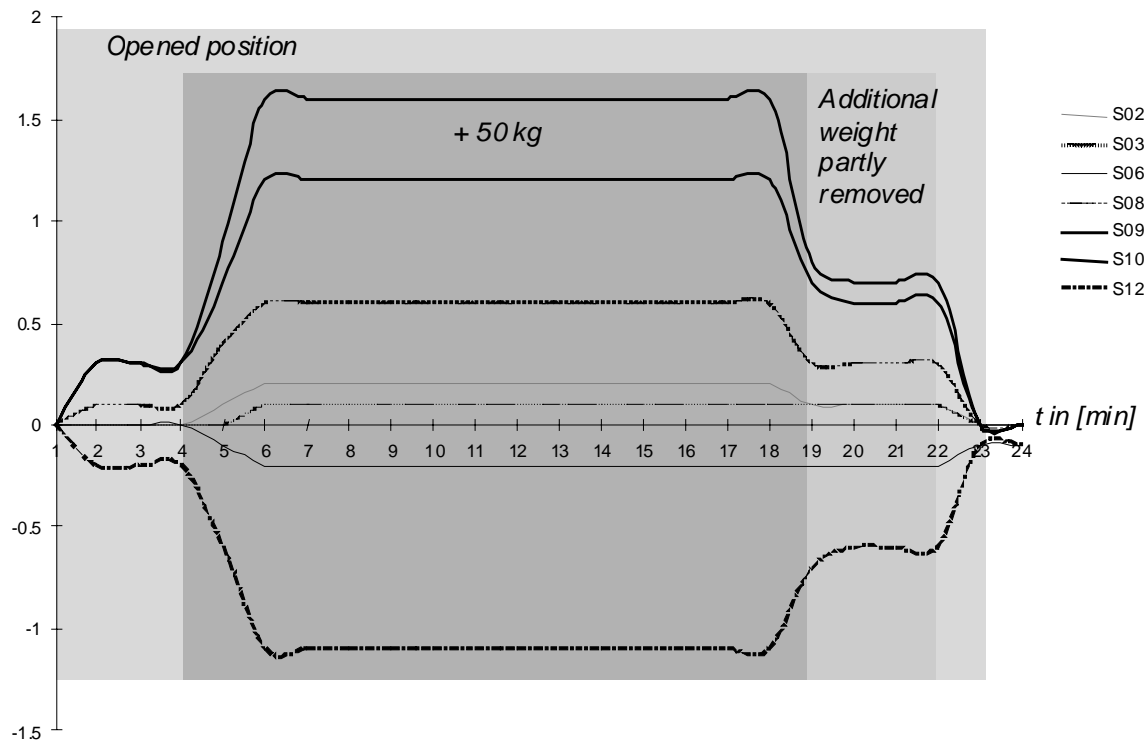
Fig. 11 Curve of displacements of measurement points S02, S03, S06, S08, S09, S10 and S 12

The casement, opened to an angle of approx. 90°, was exposed to an additional load of 50 kg on the locking side. After a loading time of 25 minutes, the additional weight was removed and the window closed. The measured values are presented in Fig. 10. The deformation of the window was reversible; no permanent deformations or visible changes occurred, as shown in Fig. 11.

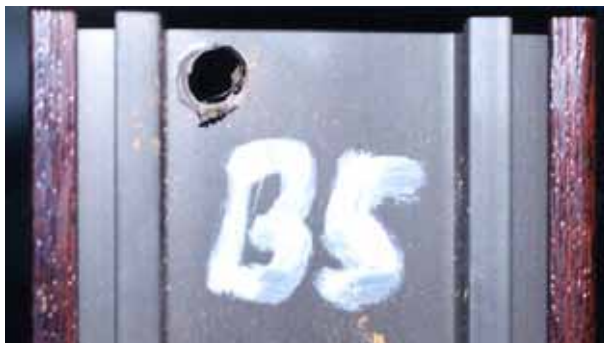
Fig. 15 Screw hole B5

The window was dismantled and the screws were found to be holding firmly. Due to the bearing pressure, slight expansions of the screw holes in the window could be determined (Fig. 14). These expansions occurred in the lower plastic bar, due to the absence of a metal wall in this area (Fig. 15).
